Safety Inspection Report

Annual Inspection

Playing Fields

Walberswick Parish Council

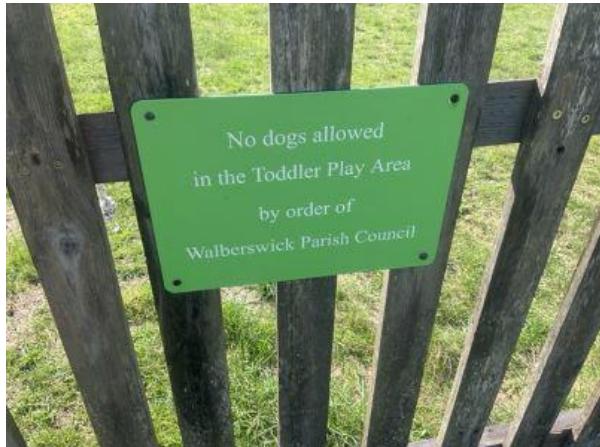
Signage - Ownership

Sign does not include at least the minimum information required i.e. telephone contact / dog exclusion / owner.

Either no site name, no location details or no contact details etc.

Provide the correct information.

Commented [AL7]: New sign obtained with email address on (telephone number will not be provided as not a parish council owned phone) - just needs to be fitted

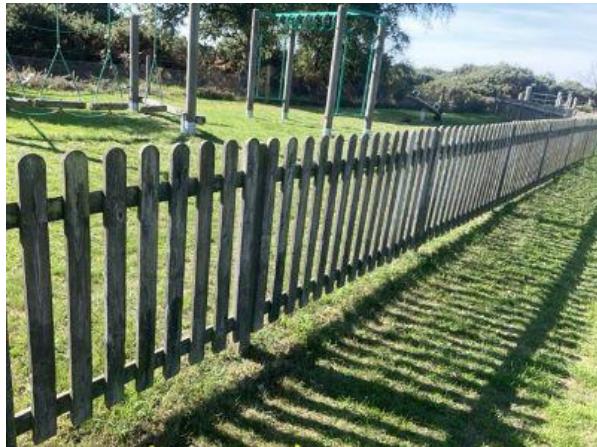
Fencing

Item is not secure.

Corner panel loose to the post exposing screw heads.

Medium

Secure.

Commented [AL8]: To be actioned

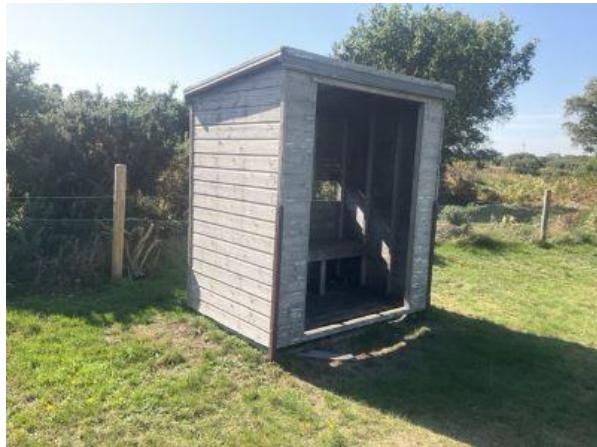
Shelter

Timber is decayed.

Wall panels damaged and Floorboard decayed and missing leaving a large hole this could entrap feet etc.

Medium

Roof panel is damaged.

Felt ripped off the roof.

Replace affected parts.

Commented [AL9]: WCLC already instructed to remove it entirely (it belongs to them) - follow up email to be sent

Repair.

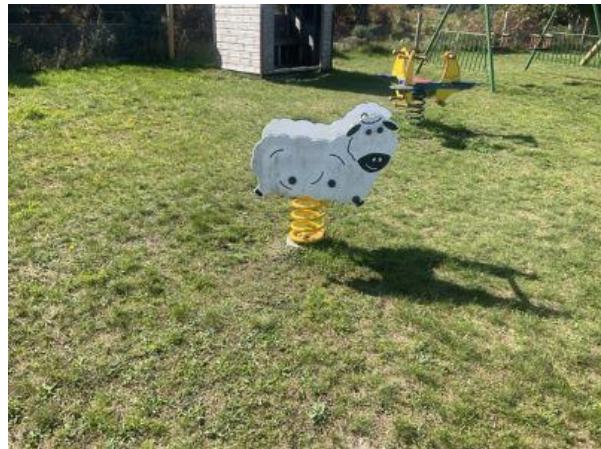
Rocker - Sheep

Loose in ground.

Unit working loose in the ground. Monitor and reset if the unit becomes unstable.

Read the notes for further action.

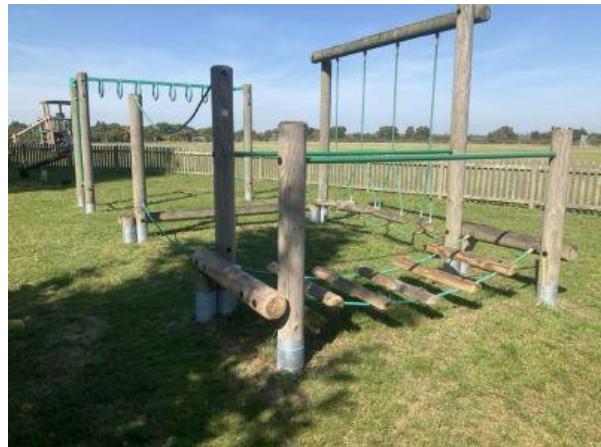
Climber - Frame - Square

Fixtures loose or missing.

Suspended log walk rope top bar fittings loose and moving. Secure in correct place.

Strimmer damage is present on posts, allowing water to enter and timbers to soften. It can also remove the protective envelope around the timber. Prevent further damage and check timbers for decay throughout the year.

Timber posts have a protective cover on at ground level. Unable to inspect for ground rot. We advise the client to remove the covers to check for rot and softening of the timbers through trapped moisture etc.

Tighten.

Commented [AL10]: To be actioned

Prevent further damage.

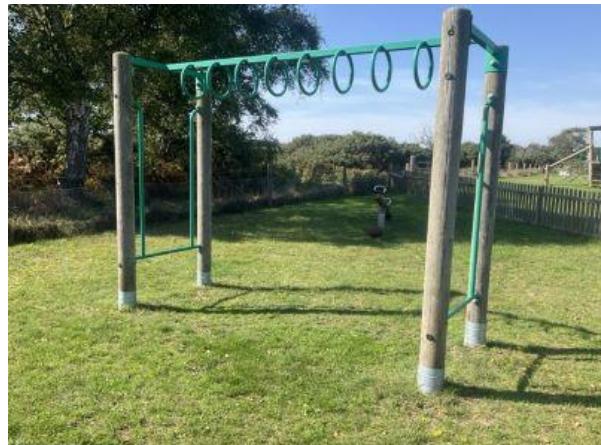
Agility - Ladder - Trapeze Rings

Overhead ladders and rings provide significant play value and benefits to children, and with it the risk of falling. Ensuring the surface remains in good condition will help to keep the correct balance between benefits and risk.

Strimmer damage is present on posts, allowing water to enter and timbers to soften. It can also remove the protective envelope around the timber. Prevent further damage and check timbers for decay throughout the year.

Timber posts have a protective cover on at ground level. Unable to inspect for ground rot. We advise the client to remove the covers to check for rot and softening of the timbers through trapped moisture etc.

The protective surface under all bars and rings must be kept in good condition.

Commented [AL11]: No action proposed as already in good condition

Prevent further damage.

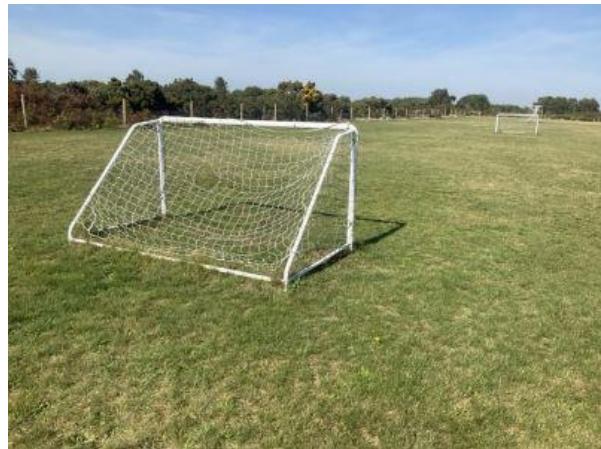
Goal Post - Football - 5-A-Side

Surface has holes in it.

Small animal holes in the playing area. Fill in on a regular basis.

Item is not secure.

Secure net to the frame.

Repair.

Commented [AL12]: Already filled in on a regular basis

Commented [AL13]: To be actioned

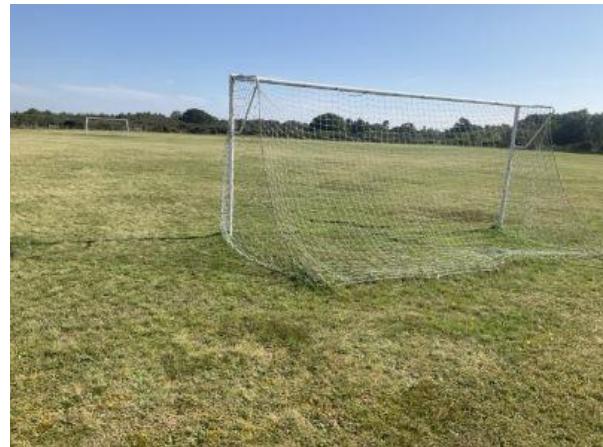
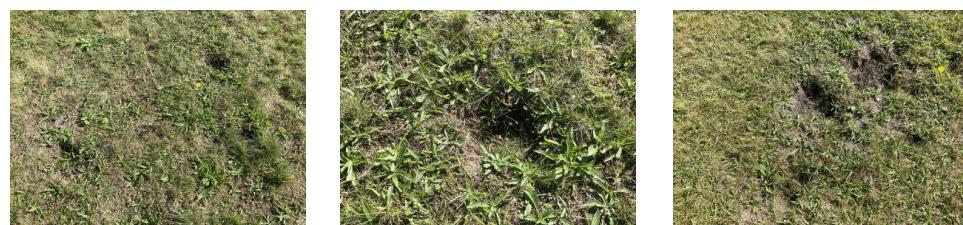
Goal Post - Football - Full Size

Surface has holes in it.

Small animal holes in the playing area. Fill in on a regular basis.

Ground erosion present.

Remove stones and reinstate the goal mouths.

Item is not secure.

Secure the net to the frame.

The structural tests within EN 748 / EN 16579 have not been done during this inspection. These can be conducted by separate arrangement.

Read the notes for further action., Repair.

Commented [AL14]: Already filled on a regular basis

Repair the worn areas.

Commented [AL15]: Already done on a regular basis

Secure.

Commented [AL16]: To be actioned

Arrange to conduct the appropriate tests.

Commented [AL17]: No action proposed as risk is so low - not a good use of tax payer money
